Study of EUV Mask Defect Inspection and Repair Using Conventional Tools and Techniques

Toppan Printing Co., Ltd.
Technical Research Institute
Semiconductor Related Research Laboratory

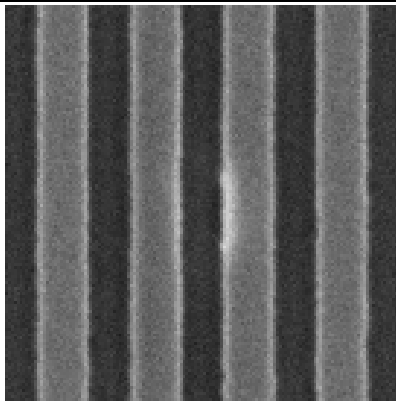
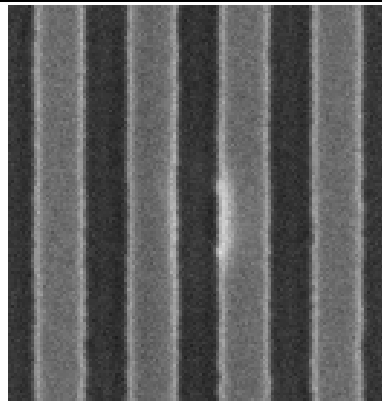
EUV Mask Repair Test

| Recipe | A | B |
| Repair Tool | EB tool | |
| Condition | Standard condition | Optimized setting |
| Post Repair | | |

- Right after repair process, these repaired sites do not show any problem.
- But it is known that repaired pattern shape changes as time advances.

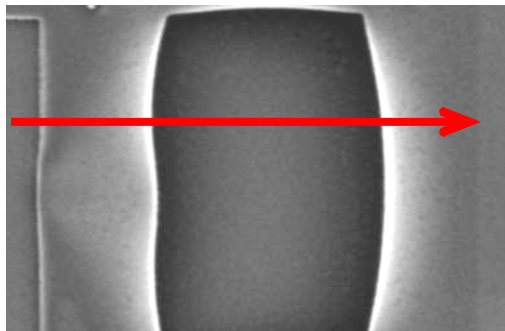
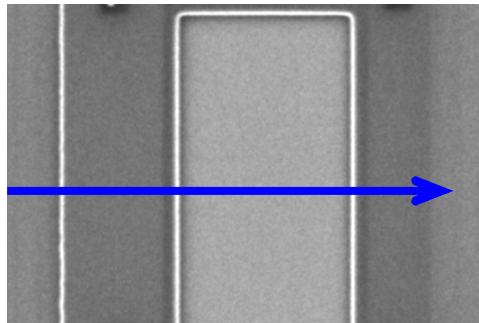
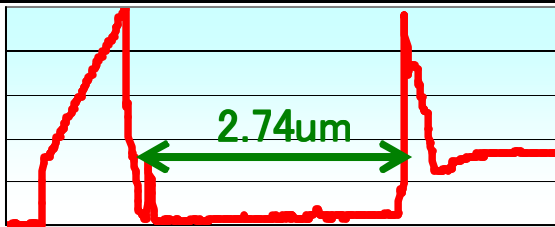
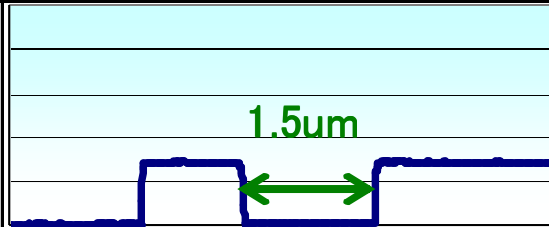
Repair Shape Assessment

- Checked repair shape after 1 day since repair was done.

| Recipe | A | B |
|---|---|--|
| 1 day after repair | | |
| Cross section by AFM | | |

- Condition A showed dramatic shape change.
 - The size of the pattern grew almost double from original size.
- Condition B did not show any difference from original shape.
- The optimized condition does not appeared to cause time dependent change.

- Developed new recipe to improve post-repair pattern shape.
- Confirmed post-repair pattern shape was very stable.
- Succeeded to stabilize EUV mask repair quality.
- Need to evaluate new recipe is applicable for actual defect repair process.
